# Evaluation Report

# 636

## Case International 8460 Round Baler

## CASE INTERNATIONAL 8460 ROUND BALER

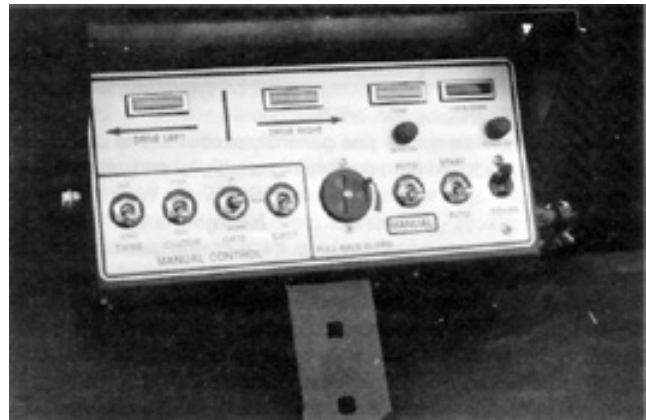
FIGURE 2. Case International 8460 Monitor.

lically actuated and can also be manually controlled at the monitor. The monitor system also contains an audible alarm for indicating a full bale condition, a light to indicate when the tailgate is closed, a light to indicate when the twine is or is not feeding, and direction lights to instruct the operator which direction to drive in order to fill the width of the bale chamber uniformly.

Detailed specifications are given in APPENDIX I. FIGURE 1 shows the location of major components and FIGURE 2 shows the monitor.

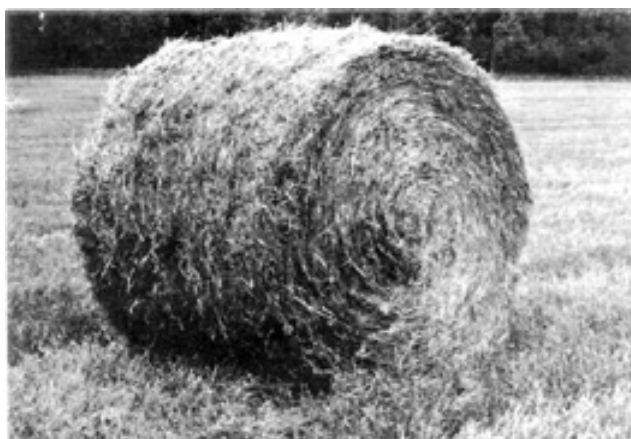
FIGURE 3. Typical Round Bale.

**Bale Quality:** Bale quality was generally excellent. The Case International 8460 produced firm, durable bales with flat ends and uniform diameter in all hay and straw crops (FIGURE 3). With the driving sensors set correctly, the operator could follow the direction lights on the monitor to produce a uniform bale. If the driving sensors were not adjusted correctly cone-shaped or barrel shaped bales often resulted. The proper adjustment of the sensors was easy to perform.

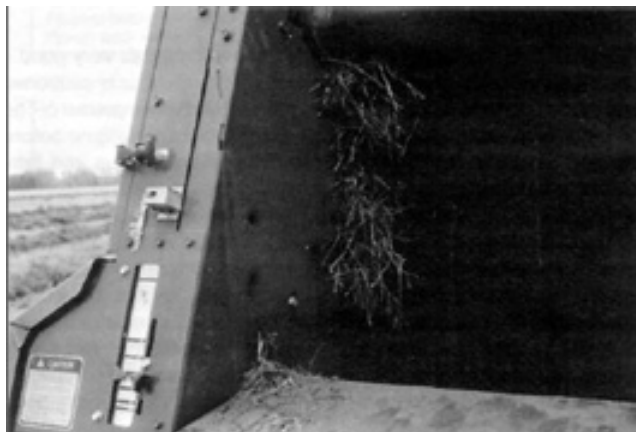
FIGURE 6. Crop Running up the Outside Forming Belt.

The baler plugged occasionally when baling short, dry crops in windy conditions. The wind blew dry crop between the driveline shield and the forming belts at the front of the baler, thereby allowing crop to collect on the twine knife shield. The forming belts then carried the collected crop up the front right side of the baler (FIGURE 6), where the crop found its way behind these belts and onto the bottom drive roller. Here the crop wrapped around the right side of the bottom drive roller and in time forced the belts to bear into the starting roller (FIGURE 1), which activated the main drive clutch. This problem occurred in both hay and straw. It is recommended that the manufacturer consider modifications to prevent crop from being carried behind the forming belts above the twine knife shield and subsequently wrapping around the right side of the bottom drive roller.

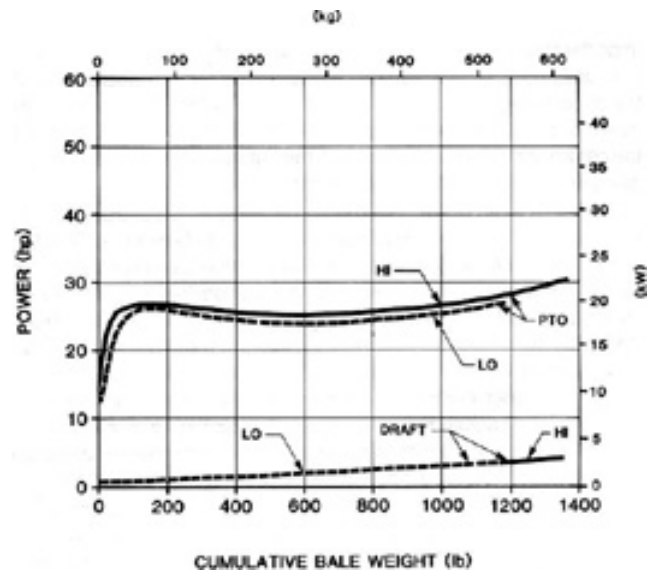
**Power Requirements:** FIGURE 7 shows typical PTO and drawbar power requirements for the Case International 8460 at a workrate of 12.2 ton/h (11.1 t/h) and 14.2 ton/h (12.9 t/h) for a high and low density bale respectively. The power input is plotted against the bale weight to show the power requirements while each bale is formed. The curves are an average of the highly fluctuating measured PTO data which varied

FIGURE 7. Typical Power Consumption During Bale Formation in Alfalfa (HI) High Density Bale, (LO) Low Density Bale.

from 12 to 16 hp (9 to 12 kW) at no load to a maximum of 37 hp (28 kW) in alfalfa for full sized bales. Drawbar requirements at 5.5 mph (9 km/h) were about 3.5 hp (2.6 kW) and 4.0 hp (3.0 kW) when the bale reached full size for low density and high density bales respectively. Although maximum horsepower requirements did not exceed 41 hp (31 kW), additional power was required to suit other field conditions such as soft and hilly fields. To fully utilize baler capacity, PAMI recommends a tractor of at least 65 hp (49 kW) in order to have sufficient power reserve in all field conditions.
